**Docket No. 217 – Development and Management Plan Inspection**

Northeast Utilities Service Company Certificate of Environmental Compatibility and Public Need for the construction of a 345-kV electric transmission line and reconstruction of an existing 115-kV electric transmission line between Connecticut Light and Power Company's Plumtree Substation in Bethel, through the towns of Redding, Weston, and Wilton, and to the Norwalk Substation in Norwalk, Connecticut.

**Date:** November 2, 2005

**Location:** 115 kV Underground Route

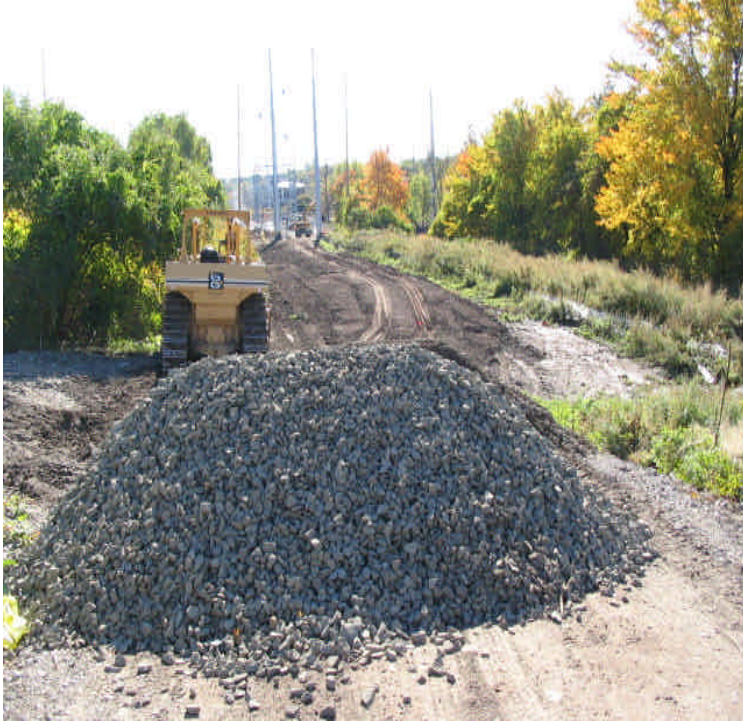
115kV (Broad Street and ROW): The photo on the left shows an overview of the ROW with topsoil and a few stockpiles. Photo on the right shows an apparent small concrete washout that occurred on the ROW. 11/2/05

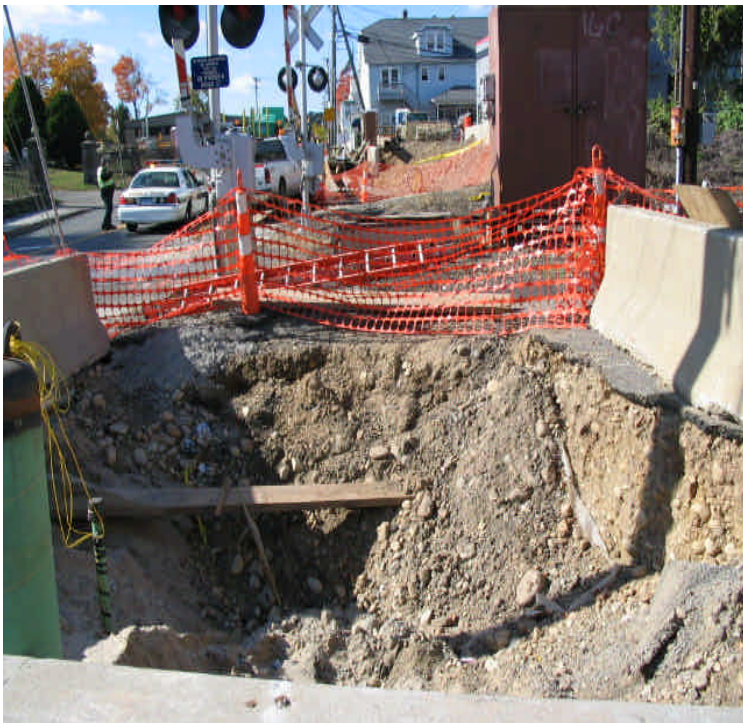
115kV (Route 7): Photo on the left shows the receiving pit of jack and bore having been mostly backfilled. Photo on the right shows some evidence of sediment/asphalt "pebbles" left behind along the road's edge. This should be swept up. 11/2/05

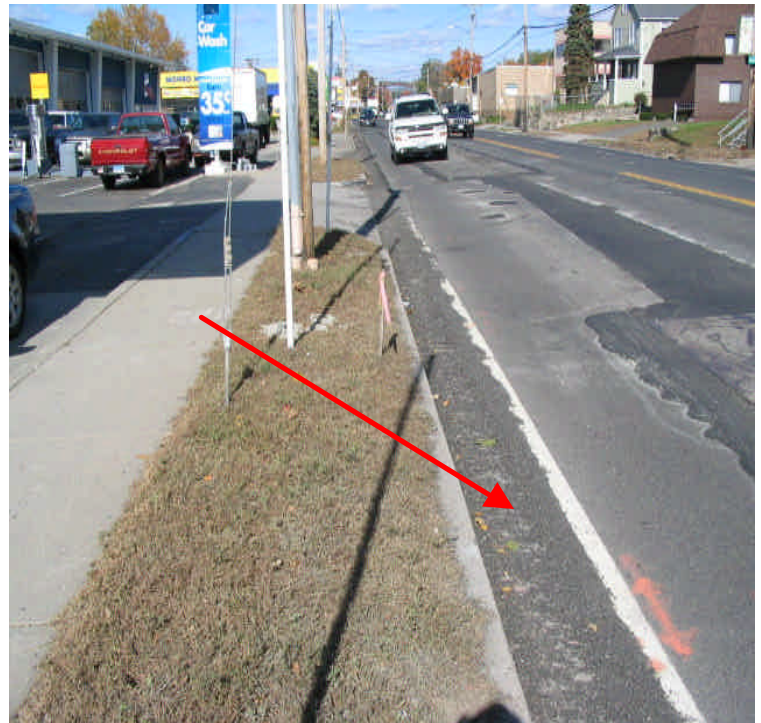
Areas of Inspection	Observation	Recommended Action
<b>Rt. 7, Norwalk</b>	<p>- It appears that sediment/asphalt “pebbles” were still present in the gutters from Rt. 7 nightwork. 10/19-11/2/05</p> <p>-115kv work was complete at Norwalk Junction but absorbent booms were still left behind at the site. 10/27-11/2/05</p>	<p>- Continue to use the vac truck for any sawcutting muds and be sure to sweep up leftover materials as part of “good housekeeping”. 11/2/05</p> <p>-Remove and dispose of the booms appropriately. 11/2/05</p>
Contaminated Soils	<p>-Soil disposal is no longer a major component of the project as most areas of trench work are completed. Clean process was brought in to bring roadways to grade. All remaining soil work is still being handled as approved. 11/2/05</p>	<p>- All soils appear to be handled appropriately. 11/2/05</p> <p>- It has been determined that the Redding landfill will use all soils from the roadways in Redding that are considered clean, (based on acceptable RSR levels), as daily cover.</p>

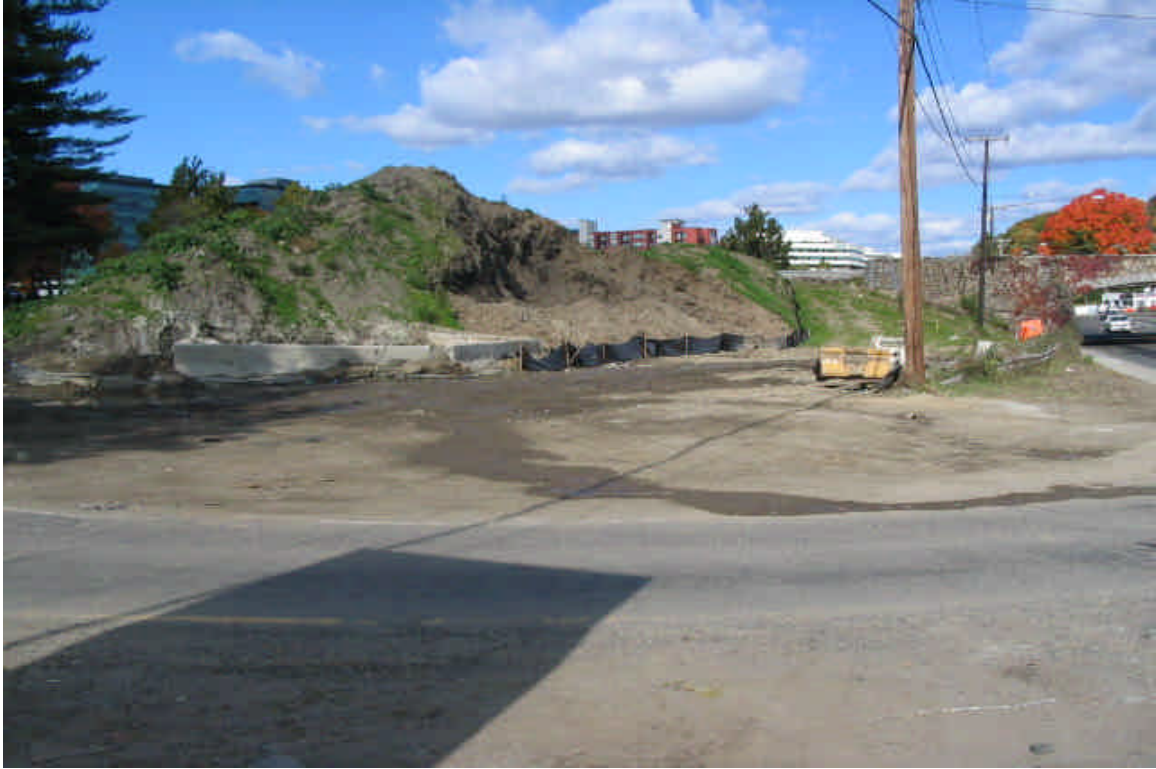
Photo shows the Merritt cloverleaf concrete washout with controls in disrepair again. Washout water will escape this area until a liner is installed. Repairs were made later this week. 11/2/05

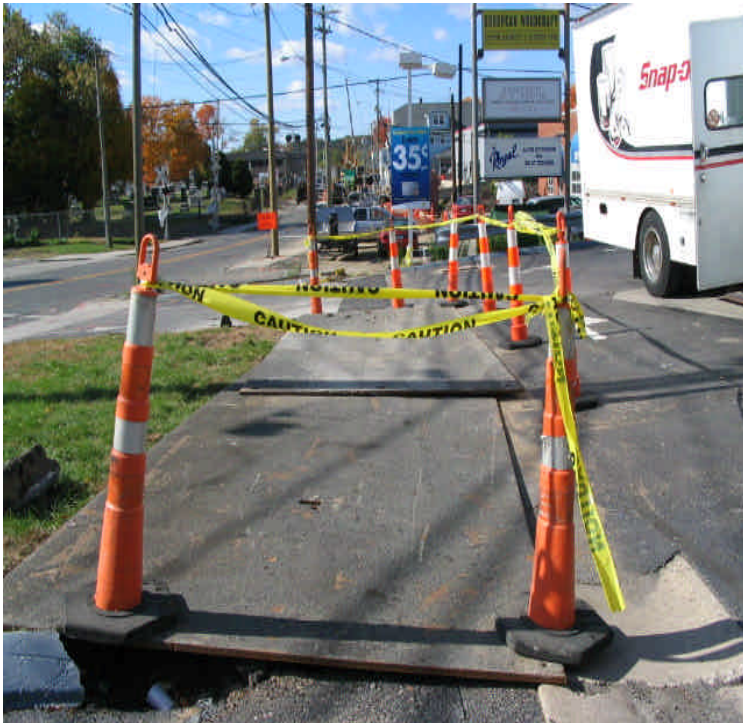
115kV (Rt 7 and Gallows Hill Rd). Photo on the left shows trenching operations from the jack and bore on Broad St. up to Rt. 7. Photo on the right shows the slope leading to the ROW placed with stone to stabilize. 11/2/05

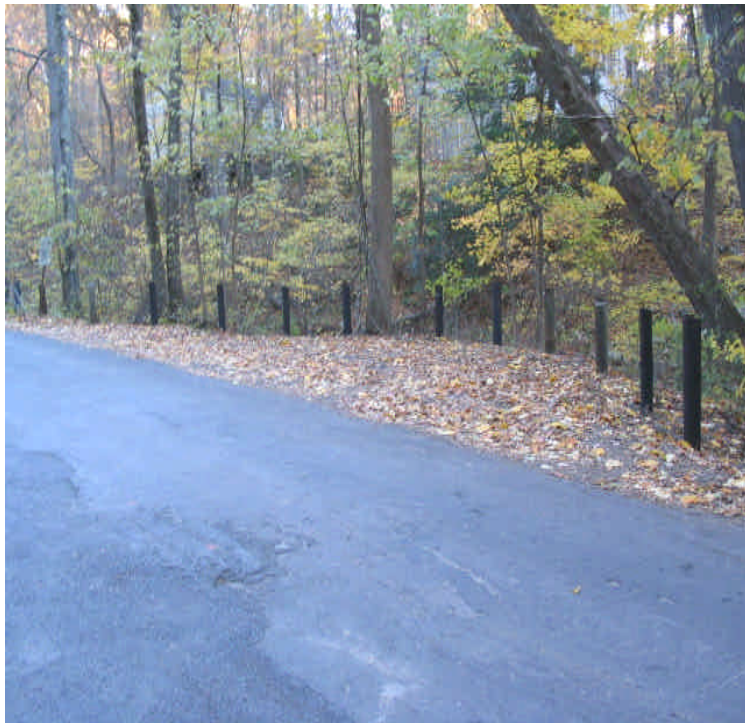
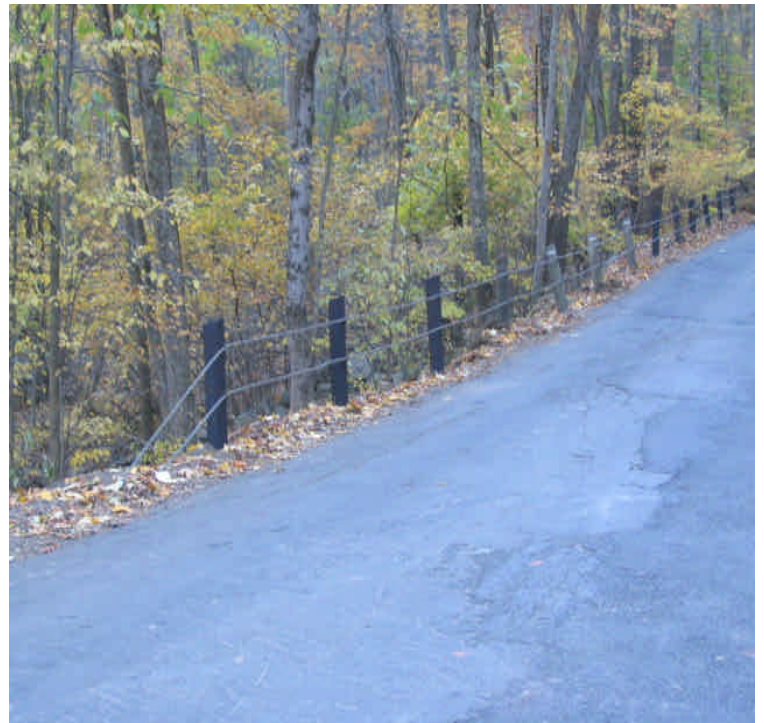
Areas of Inspection	Observation	Recommended Action
<b>Gallows Hill Road</b>	- Cable and post guardrails were repaired along the roadway and especially in the vicinity of #116. 11/2/05	- Repairs and restoration along this roadway look very good. None at this time 11/2/05
<b>Rt. 107 (Lonetown Rd)</b>	- Silt fence can be removed from areas along the roadway if they are stabilized with seed/mulch even with work returning for permanent grade. 10/19-11/2/05  - Active roadwork was noted here, including cable pulling. Catch basins were protected for the most part. 11/2/05  - Work materials were still noted near Lois Lane. The bank cut area here should be restored when work is complete. 10/5-11/2/05	- Monitor road work and make sure no soil is stockpiled. Restore the roadside if equipment causes disturbance during this phase. 10/19-11/2/05  - None at this time but restore when work is complete. 10/5-11/2/05

Both photos show nice restoration/replacement of the posts and cable guardrail along Gallows Hill Rd. 11/2/05

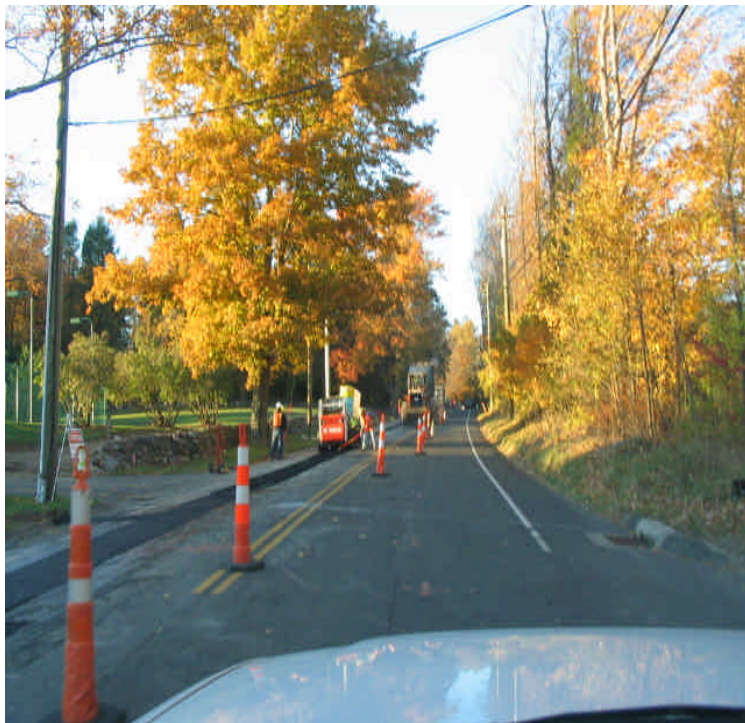
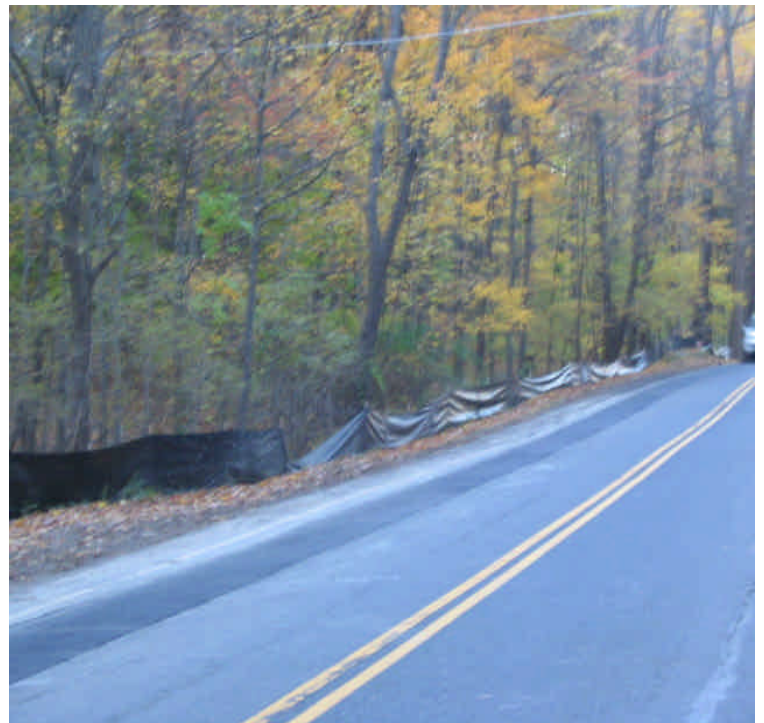
115kV: (Rt. 107 and Rt 58). Both photos show the work to bring the state routes to permanent grade. Cable work was also occurring along Rt. 107 in the photo on the left. 11/2/05

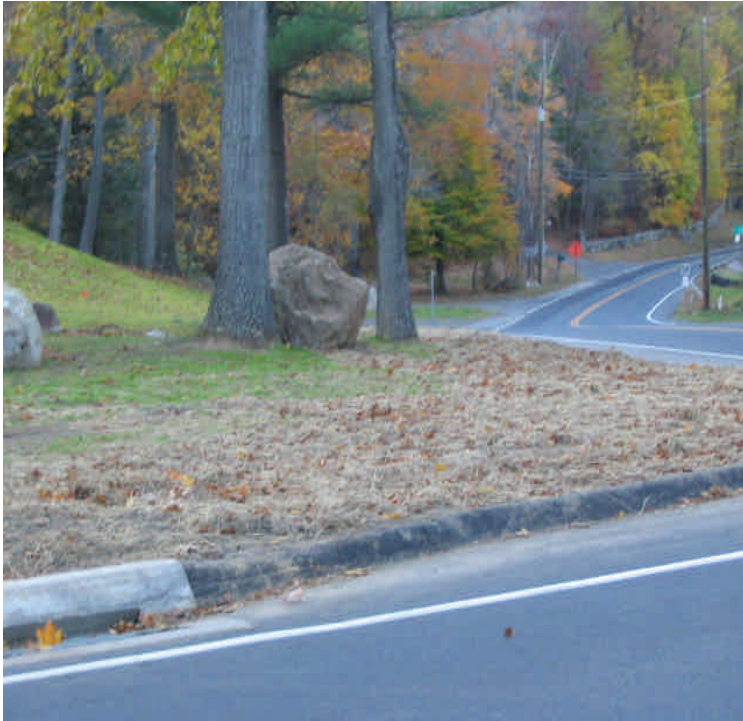
115kV (Rt. 58): Photo on the left shows good restoration of the Putnam Park area where the most recent vault transition/trench work had occurred. Photo on the right shows the silt fence north of Sunoco where stormwater has washed over it. The roadway edge should be restored and the silt fence pulled or the silt fence should be repaired. 11/2/05

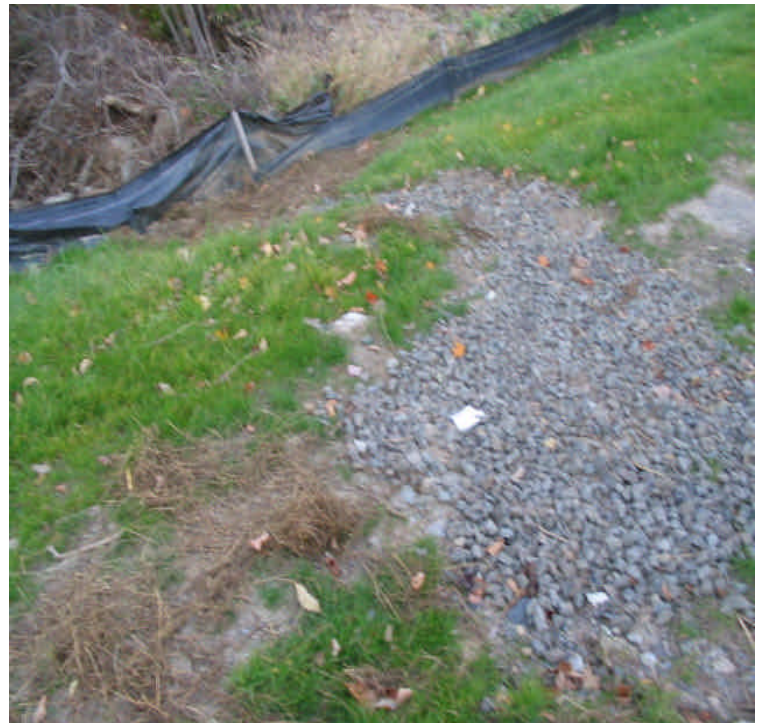
Areas of Inspection	Observation	Recommended Action
<b>Bethel Educational Park</b>	<ul style="list-style-type: none"> <li>- The gully noted on the northern part of the ROW has been placed with stone and will hopefully remain stable. 11/2/05</li> <li>- A small washout was also noted along the southern ROW. 10/27-11/2/05</li> <li>-Silt fence was in good shape in all locations. The slope at the southern end of the ROW remains stable at this time. 11/2/05</li> </ul>	<ul style="list-style-type: none"> <li>-Continue to monitor but the stone placement looks good. 11/2/05</li> <li>- Continue to monitor. 11/2/05</li> <li>- If necessary, place mulch and seed or less preferable, stone along the slope to further stabilize. 11/2/05</li> </ul>
<b>Hoyts Hill Riser Transition Structure (Off Rt. 58)</b>	<ul style="list-style-type: none"> <li>-The transition structure has been installed here. Erosion controls can be removed around the upgradient portion but should remain at the low points. 10/27-11/2/05</li> </ul>	<ul style="list-style-type: none"> <li>- Remove upgradient erosion controls when convenient. Equipment will return here for some cable work but the area should be stabilized after that. 11/2/05</li> </ul>

115kV (Rt. 58 and Bethel Ed. Park): Photo on the left shows some sawcutting material potentially getting off the roadway edge in the vicinity of the stream. The photo on the right shows the stone fill placed in the gully at the northern end of the ROW in an attempt to stabilize it. 11/2/05
